HOUSATONIC RIVER BASIN
HINSDALE, MASSACHUSETTS

CLEVELAND BROOK RESERVOIR DAM
MA 00225

PHASE I INSPECTION REPORT
NATIONAL DAM INSPECTION PROGRAM

JUNE 1979

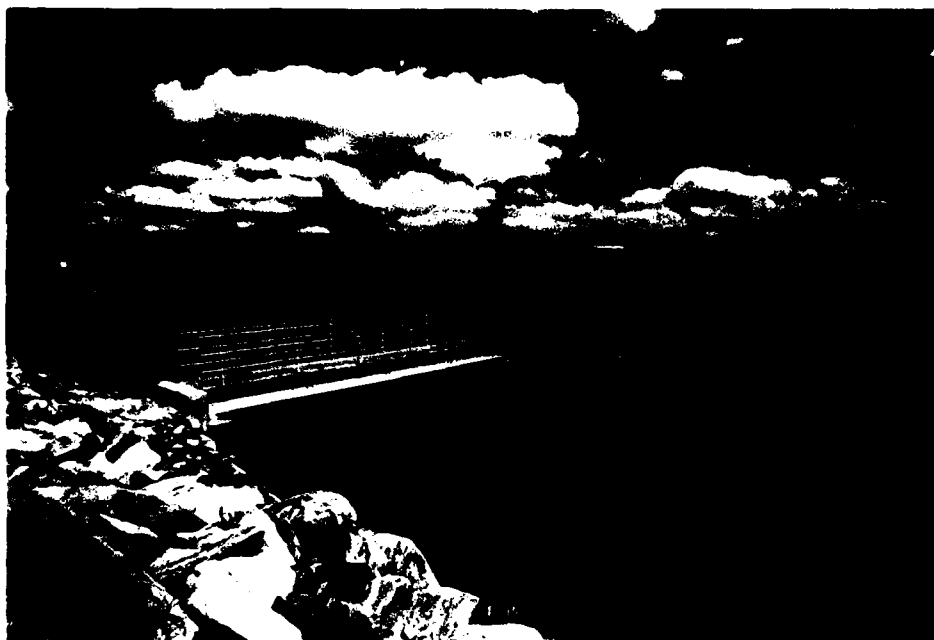
The intake gatehouse (control tower) as shown in Photos 8 and 9 appears to be in very good condition. The only deficiency noted was that the approach to the service bridge at the dam end is low as shown in Photo 8.

8. INTAKE GATEHOUSE (CONTROL TOWER) FOR WATER TRANSMISSION MAIN.
